Built for Generations: A 40-Year Test of GRP Durability

In the early 1980s, Amiblu (then Vera) installed a GRP pipeline for a hydropower facility operated by Statkraft in Jøsenfjorden, Norway. Four decades later, a detailed ultrasonic inspection confirmed what long-term performance had already suggested: despite demanding service environments, the pipeline is still in excellent condition. A quality that is backed by decades of research and product development by Amiblu.

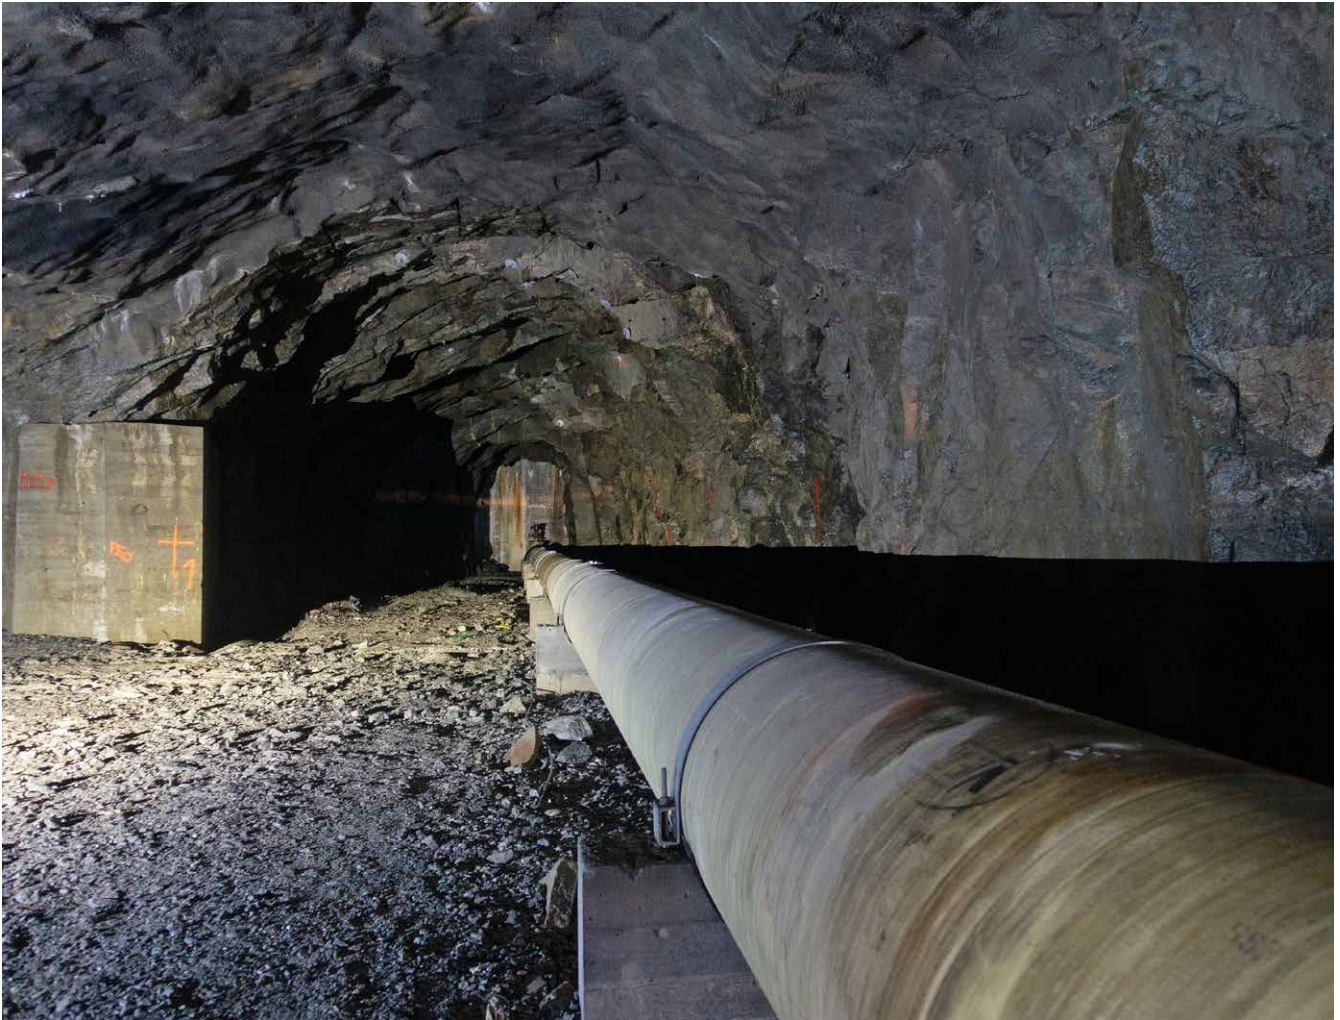
Fig. 1: GRP pipeline for a hydropower in Jøsenfjorden, Norway shows excellent condition after 40 years of operation

In October 2024, Amiblu conducted an ultrasonic inspection. The findings are remarkable: The pipe showed no visible surface cracking, blistering, deformation, or signs of wear. Wall thickness measure-

ments remained consistent with original design specifications. Even more significantly, the corrosion-resistant inner barrier – often the first line of defense in chemically aggressive applications – was found intact and undamaged. There was no sign of degradation due to chemical, physical, or biological attack.

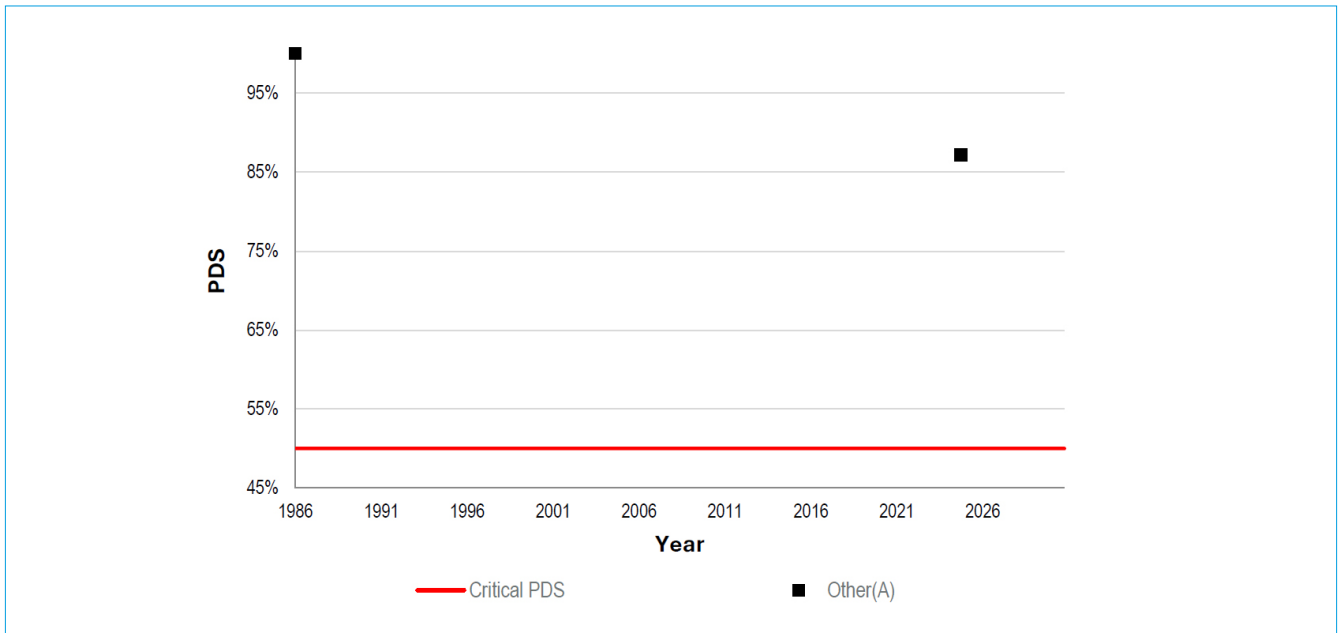
With a critical threshold for pipe condition through the UComp percent design life factor (PDS) set at 50%, the tested section showed a healthy 87% PDS – well above the limit for more frequent monitoring. This indicates that the material retains much of its original mechanical strength and structural stability. Minor external wear such as small deposits of minerals and isolated rust on supports had no impact on the pipe's integrity.

Fig. 2: Full thickness PDS over the asset service life

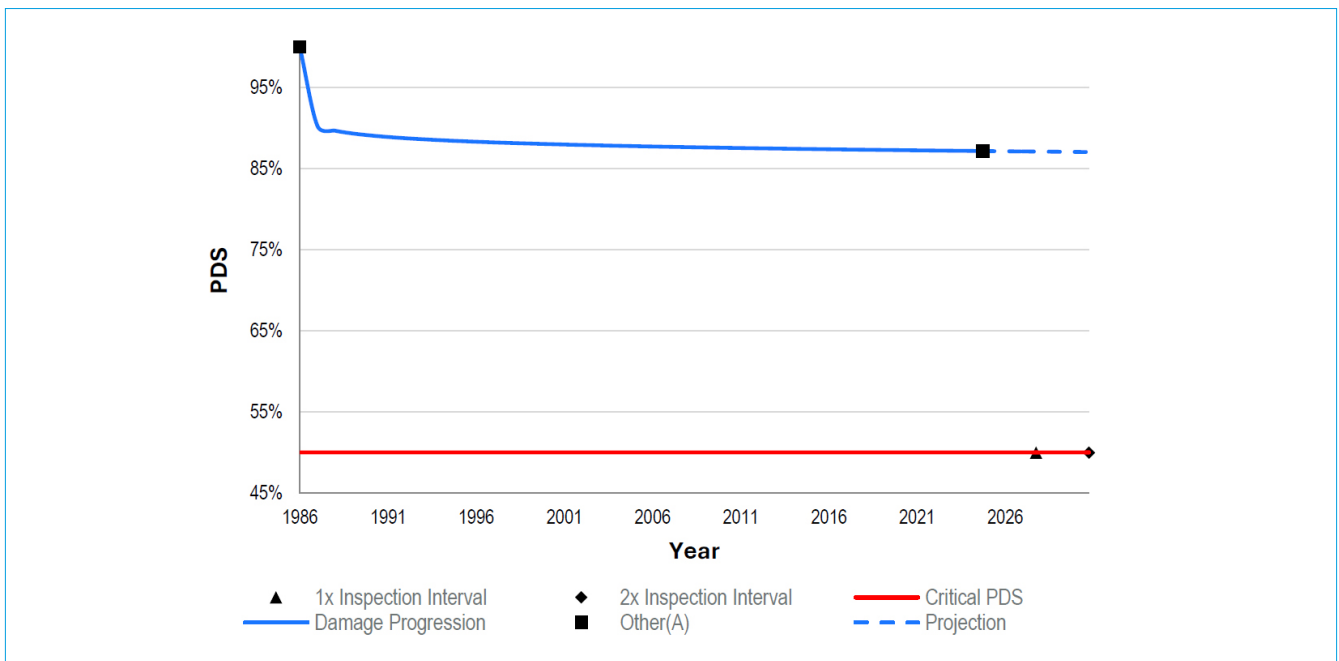
Historical performance modeling and current inspection data support the conclusion that the pipe can continue in service well beyond the next scheduled evaluation, which is set for 2027. This case represents not only a milestone in GRP pipe operation but also a rare opportunity to observe such infrastructure at the 40-year mark – a longevity few pipe materials can match without significant deterioration. Statkraft, the asset owner, can continue relying on this infrastructure with confidence.

Fig. 3: PDS change and progression

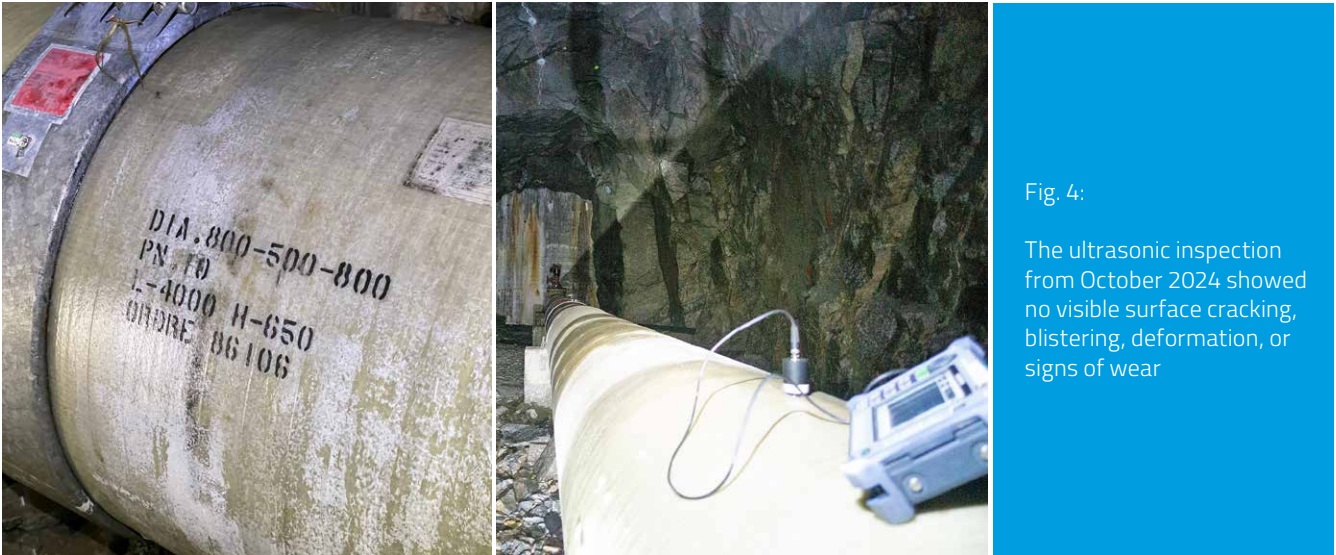
Fig. 4:

The ultrasonic inspection from October 2024 showed no visible surface cracking, blistering, deformation, or signs of wear
