CASE STUDY

Laxá II ICELAND

SUMMARY

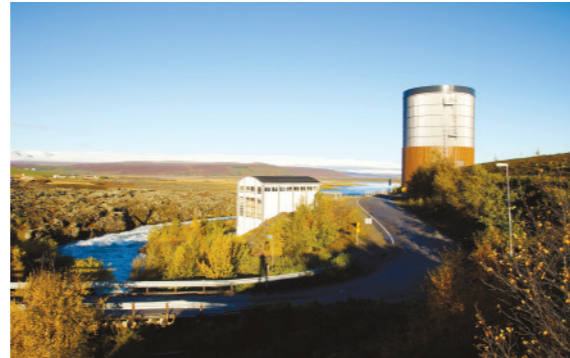
The wood stave penstock has been in operation from the beginning and around 1980 the inside bottom of the wood penstock was concreted to

prevent erosion from sand which is considerable in the river. Due to increased maintenance cost and safety reasons, the plan is to replace the wood penstock with a GRP penstock.

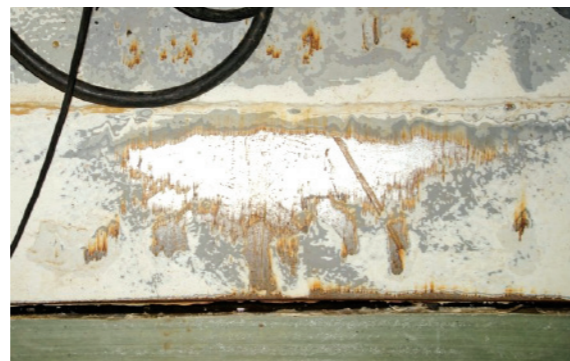
SAND FROM THE RIVER BED

The tributary Kráká coming from the highlands of Iceland runs through sandy areas where volcanic sand is blown into the river. The annual amount of sand passing the power station has been estimated to be 10 - 30 thousand tons per year (Ref. Laxá Hydropower Scheme report, Multiconsult 2013, LV2013-112). This sand causes severe abrasion issues.

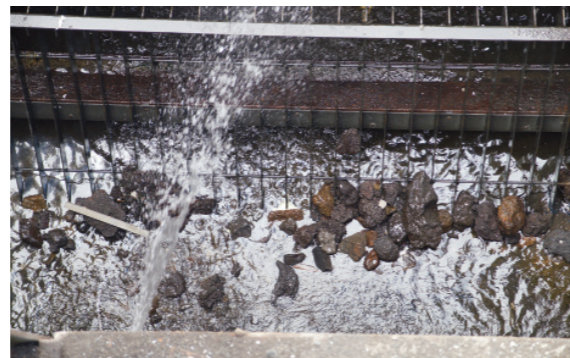
STONES BROUGHT WITH BRASH ICE AND MELTING WATER

To avoid the brash ice blocking the trash racks, the trash racks are removed from time to time. Large stones can be expected. Stones that fit the gaps between pipe spigots (largest measured gap 27 mm) have been found trapped at pipe joints, larger stones would pass the joints. Stones 50-300 mm can be expected based on video footage.

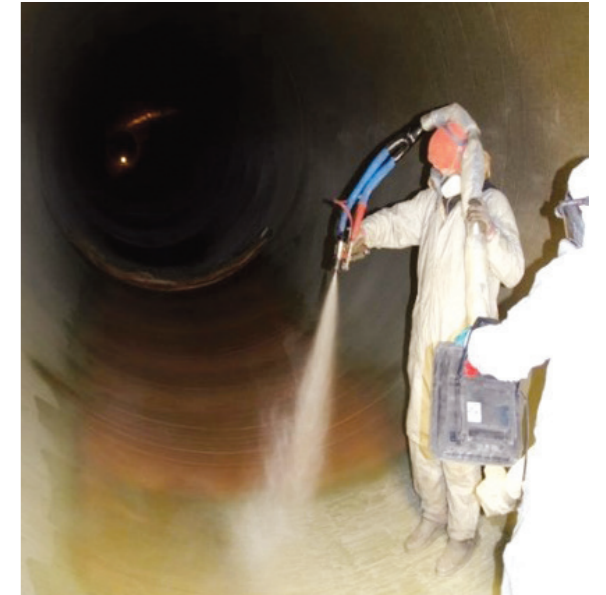
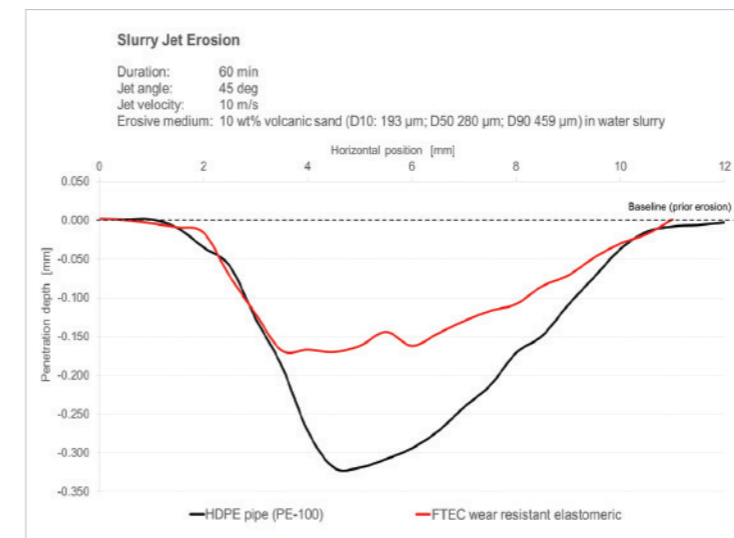
The solution for the abrasion water in the Laxá pipe was the application of an additional elastomeric coating material. The coating material was chosen from an extensive development project for high wear resistance pipe liners which has now culminated in Flowtite Orange.

The elastomeric coating chosen has good erosion and abrasion resistance coupled with good mechanical properties including toughness and elongation. The pipes were first prepared for the coating which was applied with spray equipment in one single pass. The preparation of the pipe ensures good adhesion between pipe and coating. The coating was applied at 2 mm thickness and confirmed by non-destructive thickness measurements.

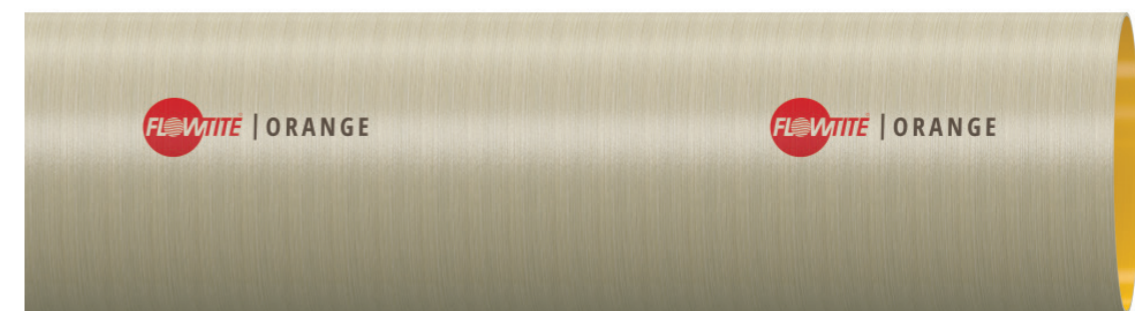
Inspection of the coatings after one and two years in service noted no significant reduction in thickness with 92-100% of coating still remaining. The ability of the elastomeric coating, and now Flowtite Orange, to provide good wear resistance is well supported from field experience in Laxá.
