GRP pipes are designed for generations. Here's the proof.

A generations-long, low-maintenance service life: It's a promising claim that Amiblu makes about their GRP products. A promise that is not just based on the company's 60 years of age and experience – there's quite a bit of meticulous scientific research involved. We talked to former Amiblu Product Development Manager Högni Jónsson who told us why we can confidently stand by our claim.

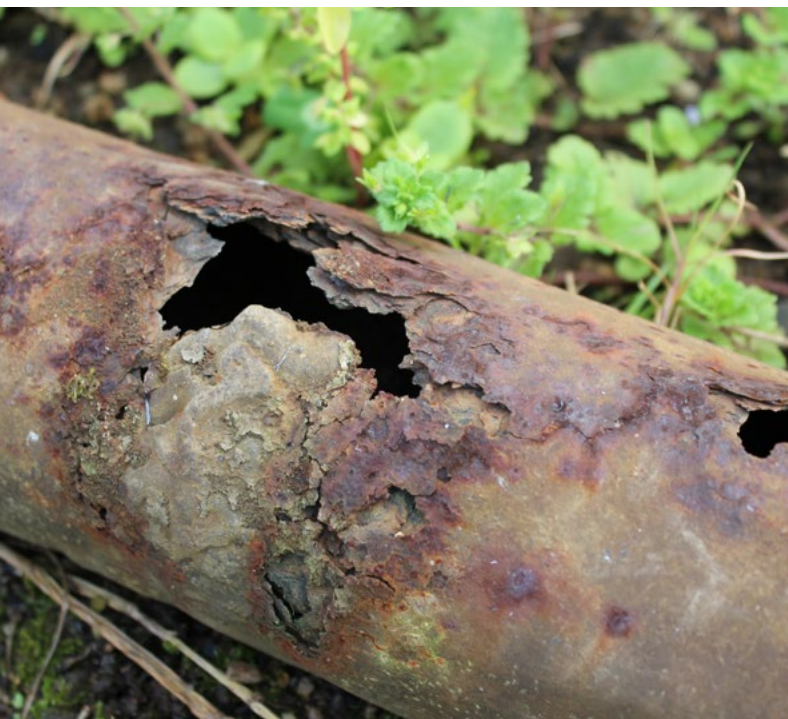
Fig. 1: Pipelines made of concrete or metals corrode in low-pH sewer environments under the influence of sulphuric acid.

Jónsson: To answer this question, we first need to look at the reasons why most pipes do *not* reach such a mature age. These reasons carry names such as thiobacillus concretivorus and thiobacillus ferrooxidans – tiny bacteria that decompose sewage and form hydrogen sulphide gas (H_2S). When combined with moist air, the gas forms sulphuric acid (H_2SO_4), which is highly corrosive to materials like concrete, steel, and cast iron. This “microbially induced corrosion” can cause significant damage over time. Corrosion is also a major problem in seawater applications, where the contained sodium chloride eats away at e.g. metals and causes them to fall apart. With GRP products, the situation is quite different.

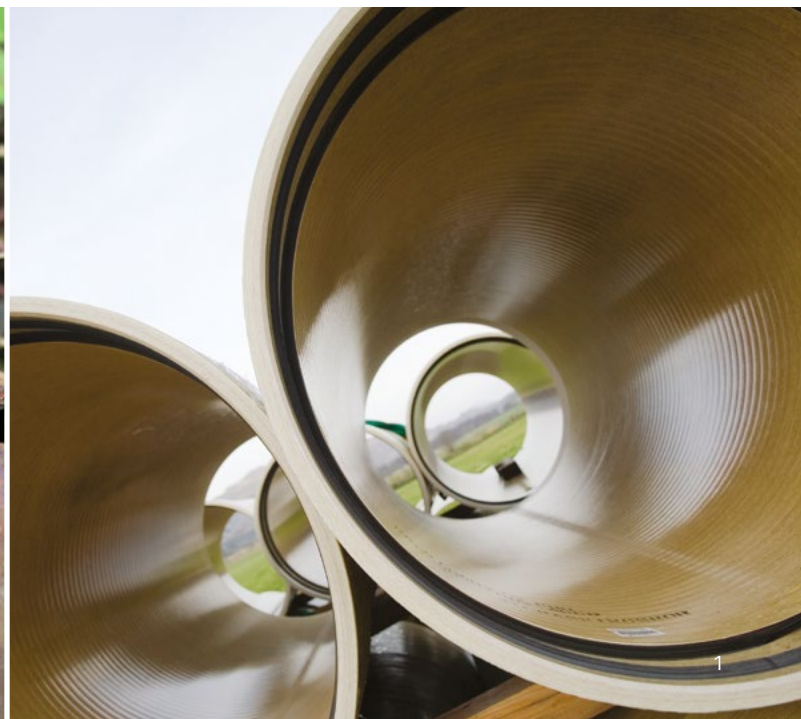
Fig. 2: GRP pipes are inherently corrosion-resistant and feature a long, low-maintenance lifetime also in harsh sewer environments.

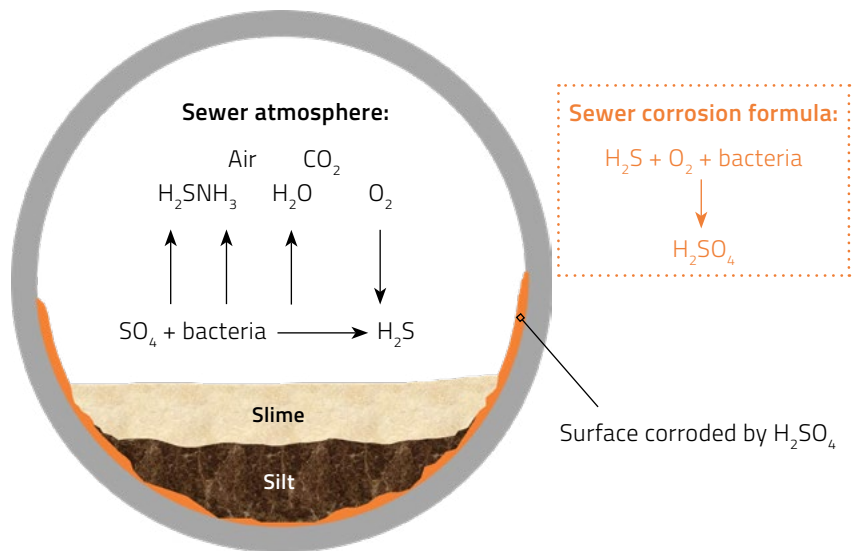
Fig. 3: The process of microbially induced corrosion. Slime and silt contain bacteria which break down organic and inorganic sulphur compounds, thereby producing hydrogen sulphide (H_2S). When the H_2S gas comes into contact with the moist surfaces above the water line in the sewer, it can combine with dissolved oxygen (O_2) to directly form sulfuric acid (H_2SO_4). However, most of the H_2S is decomposed into elemental sulfur S , which is a source of energy for the *Thiobacillus* bacteria family; they are oxidizing the elemental sulfur and their metabolic waste is H_2SO_4 . This sulfuric acid lowers the biofilm pH and corrodes concrete, steel, and cast iron.

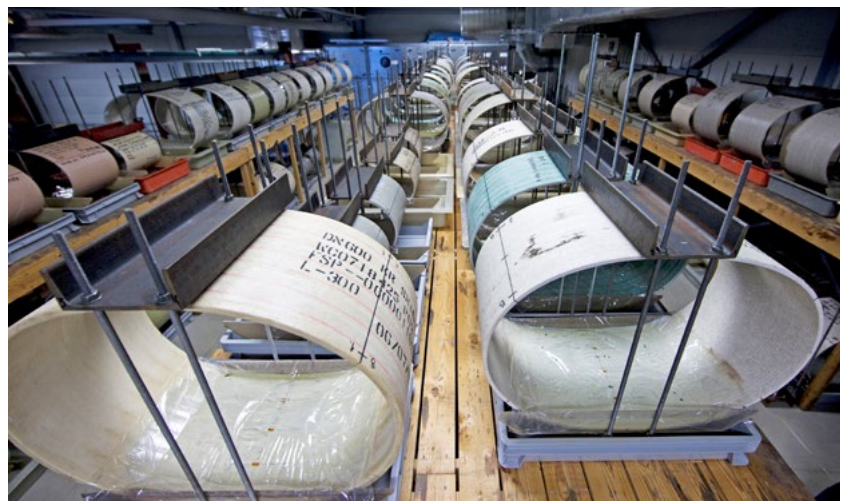
Fig. 4: Strain corrosion tests according to ASTM D3681 in the Amiblu R&D center in Norway.

Jónsson: Our tests cover a variety of pipe designs which have been in continuous use. The samples, most of them DN 600, were taken from a number of Flowtite and Hobas manufacturing plants. According to ASTM D3681, we subjected each 300 mm long pipe sample to a vertical force causing tensile bending strain in the pipe invert, while exposing it to a 5% concentration of sulphuric acid.

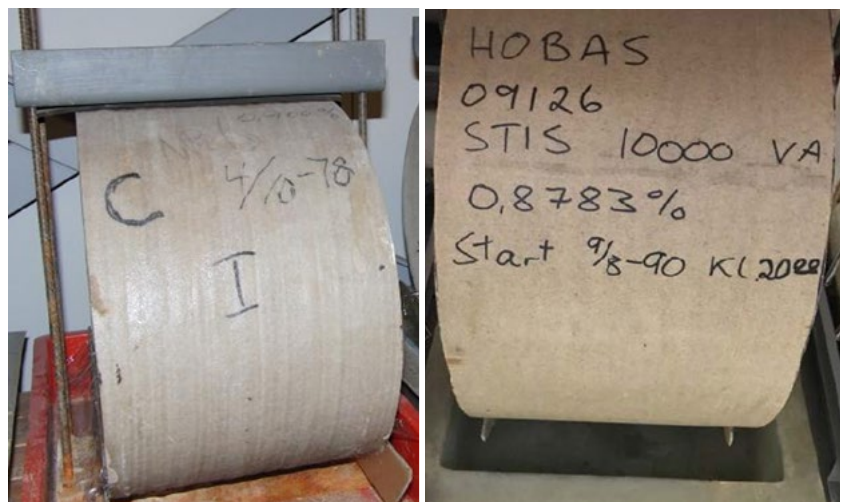
Fig. 5/6: Flowtite sample from 1978 (left) and Hobas sample from 1990 (right).

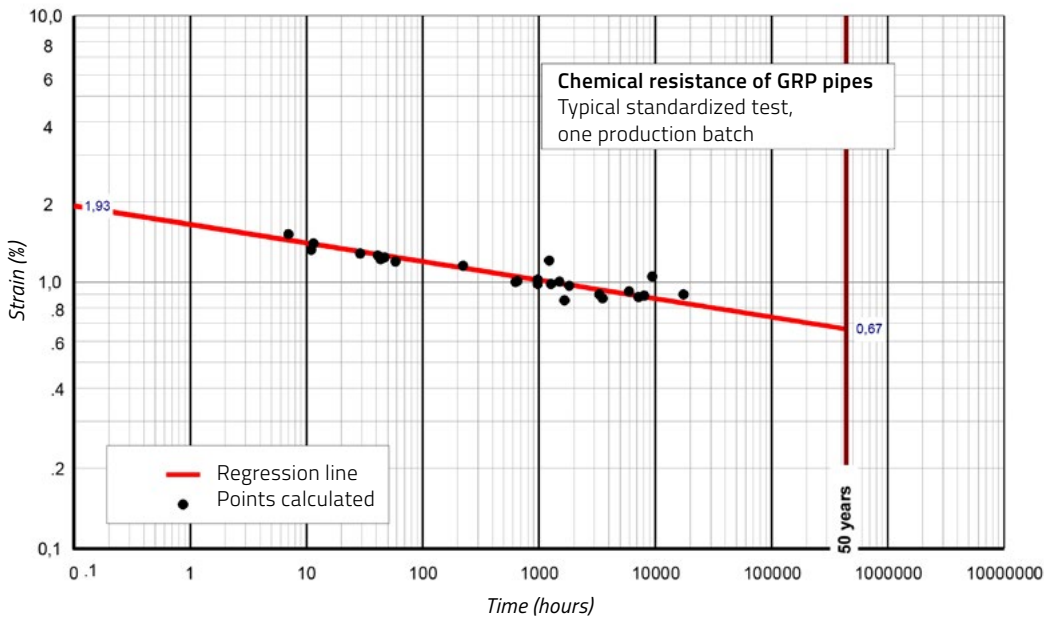
Fig. 7: A typical test series with 25 Flowtite pipe samples. The horizontal axis is the time-to-failure, the vertical axis shows the bending strain at the pipe invert, both on a logarithm scale. Each point on the graph represents a pipe sample that has been subjected to the recorded strain until failure occurred. Having fulfilled the statistical requirements, a straight line that fits the data is computed, using covariance regression analysis. In this case, the extrapolated strain value at 438,000 hours (i.e. 50 years) is 0.67%. With typical long-term deflection of 3% (yielding a strain of 0.27% for current pipe designs), the calculated safety margin is approximately 2.5.

The strain is measured after the load has been applied and then the sample is stored under controlled conditions until failure occurs, detectable as leakage through the pipe wall.

With at least one data point exceeding 10,000 hours and the rest relatively evenly spread over the time range, and with an appropriate coefficient of correlation, the data can be safely used and extrapolated with classic statistical methods.

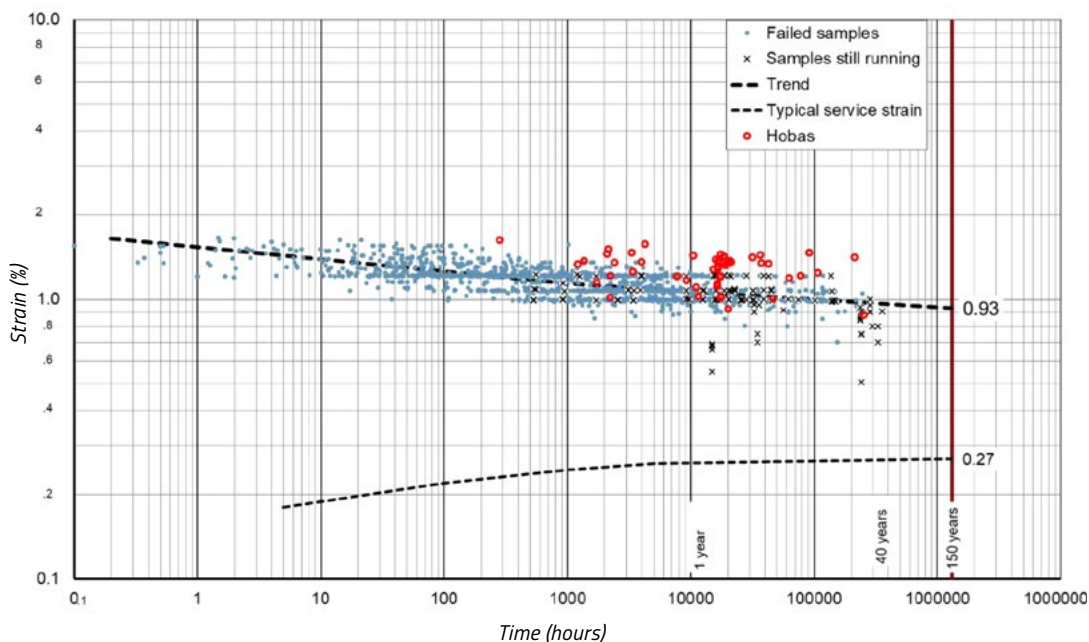
Fig. 8: The complete data of tested Hobas and Flowtite pipe samples over the past 40 years on a log-log scale. The dots on the chart represent failed samples, while the crosses represent samples that are still running. The failed samples are distributed along the whole time scale, clustering together on a relatively narrow strain-band. There are 40 samples that have lasted more than 12 years, with strains ranging from 0.5% to 1.1%. Of these, 16 have failed, while 24 are still running.

Jónsson: The shortest measured time to failure is 0.3 hours at 1.35% strain; the longest is 28 years and 78 days at 1.05% strain. The longest, still running test was set up on October 4th 1978. The sample has now been exposed to the acid test for

almost 45 years at 0.91% strain. What's really interesting here is the bilinear behavior: up to strains of about 1.6%, most samples fail within relatively short time periods. At strains between 0.9% and 1.3%, the time to failure is much longer.

Only a handful of data points fall below this range, meaning that below a certain "threshold strain", the samples simply do not fail. For this set of data, the threshold appears to be around 0.9% strain. A classic regression analysis of the data points up to 1000 hours results in a line with a mild slope. →

On the other hand, regression analysis of data points after 1000 hours through to over 350,000 hours show an almost horizontal line. By extrapolating this line by only ½ of a decade, which is less than one third of what classical statistics allows, we reached a long-term strain value of 0.93%.

Jónsson: No, and that’s the fantastic conclusion: The typical long-term operating strain of such a pipe is merely 0.27%. This means that, in real-life applications, we even reach an excellent safety margin of 3.4.

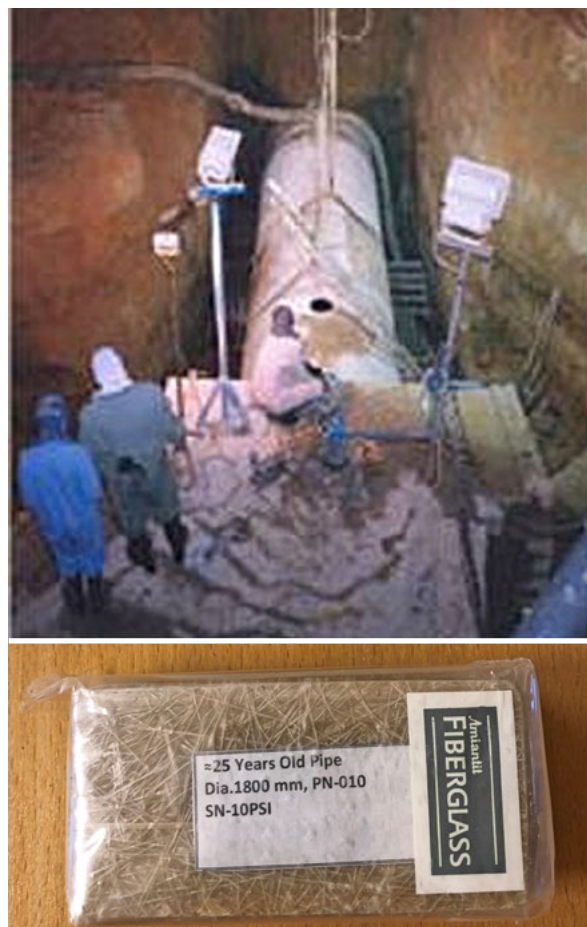
Fig. 9-10: A Flowtite GRP sewer pipe DN 1800 was unearthed and inspected after almost 25 years in service at a sewage treatment plant in Riyadh, SA. The pipe showed no signs of deterioration.

Jónsson: In 2004, a pipe DN 1800 that had been in continuous use in aggressive environment since 1980 was unearthed and inspected (Fig. 9-10). The pipe came from the sewage treatment plant belonging to the Water and Sewerage Department in Riyadh. After almost 25 years in service, the pipe showed no signs of degradation or deterioration, only a slight change in stiffness. Another sample taken from a pipe in Norway that had been submerged in sea water for more than 33 years showed no signs of corrosion or visible aging either. The mechanical properties were also well within the initial design requirements (Fig. 11-13).

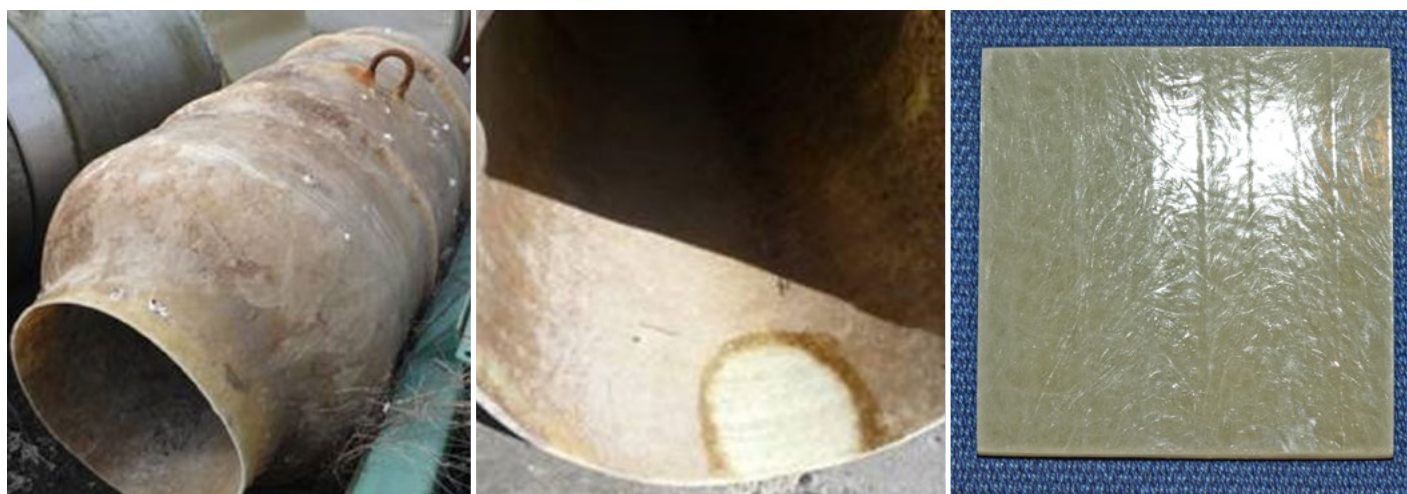
Fig. 11-13: In 2008, after 33 years exposure to treated sewer and seawater, a section of a Flowtite GRP DN 500 pipe was brought ashore for analysis of its condition and mechanical properties. After cleaning parts of it, the pipe looked almost brand-new. The pipe showed no visible signs of ageing and its mechanical properties were basically unchanged.
