All Show and All Substance in Tilburg, NL

Efficient Relining with **HOBAS®** NC Line® Wins No Dig Award

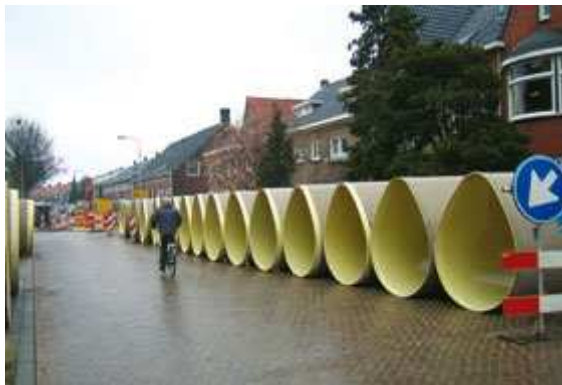
The sewer in Sint Josephstraat, The Netherlands, is part of the Tilburg main sewer and is an important link in the system of the waste water treatment plant and the rainwater overflow at the Wilhelmina Channel. Designed in 1927 and installed one year later, it consists of a concrete base with a masonry arch. Its transversal section is that of a reversed egg profile, with 1.90 m maximal width and 2.15 m height.

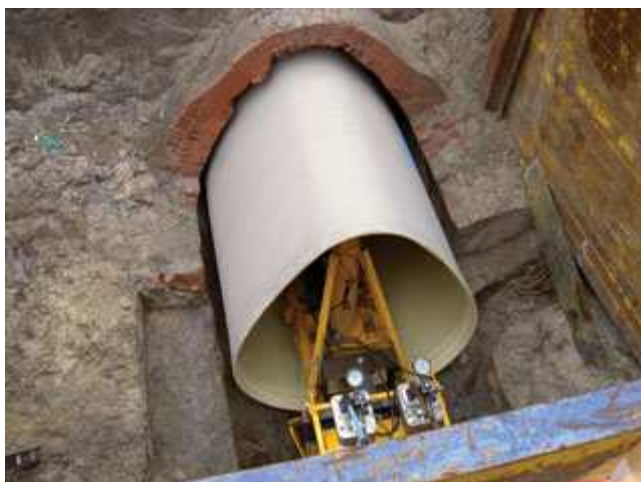
In the late 90's the road above the sewer constantly subsided. Inspection with radar equipment showed that this problem occurred due to the collapse of cavities beside the sewer. The cavities themselves developed because of sand being washed through cracks in the base of the construction. Repair works became immanent and resin was injected to stop the sand from passing through. This solution, however, proved to be unsuccessful so that the municipality of Tilburg was confronted with the question whether to take structural measures.

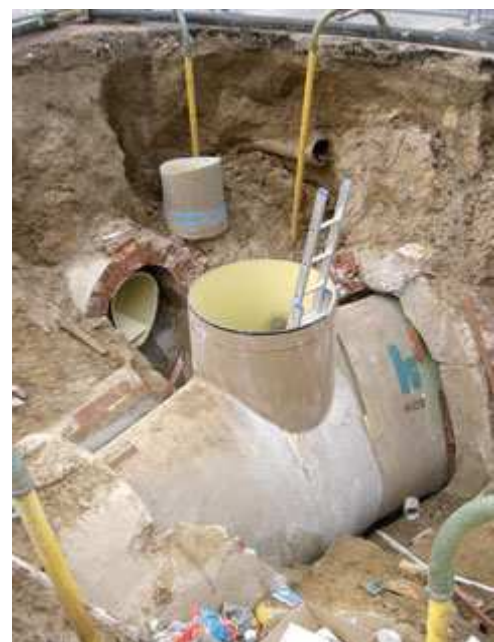
Basing the decision on the analysis, Tilburg chose prefabricated reinforced plastic (GRP) pipe elements to reline the whole affected section. An important precondition concerning pipe capacity was the maximal acceptable diameter reduction of 10 cm. This limited the number of sliplining methods ("lining with continuous" or "discrete pipes"). Another criterion was the length of the damaged section which does not exceed horizontal deviations (angle distortion) in the line.

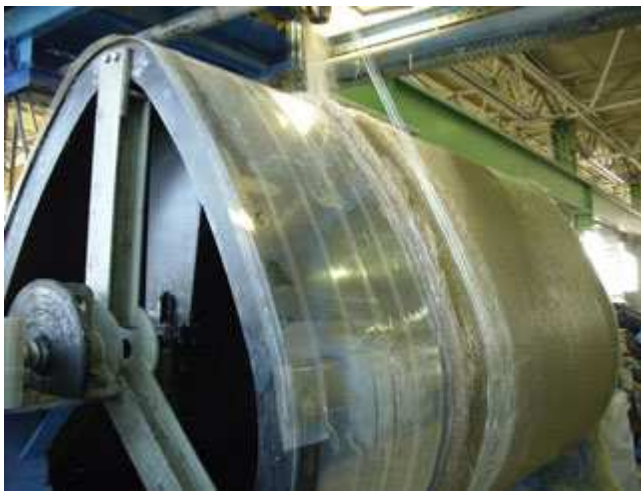
The application of (cured-in-place) hose relining could not be implemented for several reasons, mainly concerning the uneven distribution on the non-circular sewer walls which would anticipate uneven load distribution as well as possible buckling because of the required wall thickness, deviations, angles, and for simply being irreversible once applied. Apart from this, there was little experience with hose relining in large non-circular constructions as such and the method does not allow temporary use of the sewer while being applied. HOBAS NC Line therefore promised to be the better solution. During its installation the sewage is redirected. At heavy rainfall, however, the HOBAS NC Line can be used temporarily and may be evacuated within 10 minutes.
