UK – East Budleigh Culvert Rehabilitation (NC Line)

East Budleigh is a small village in East Devon, UK located about 2 miles (3.2km) north of Budleigh Salterton. The village features a bypass culvert, constructed in the 1970s. The culvert is approximately 280 metres in length, of Armco construction, oval shaped and constructed from corrugated metal sheeting (with a concrete floor laid over it during the last 10 years).

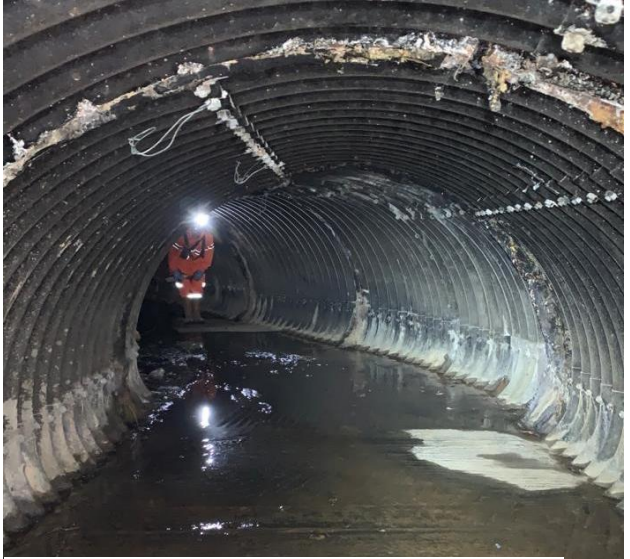
Fig 1: Host pipe inspection. Courtesy of MDA Ltd

The existing culvert was in a poor condition, with joints failing and large voids appearing in the material outside the culvert structure. These failures led to a small localised collapse in the road above during flooding in 2012 and there were concerns that in the future that a larger collapse could occur, causing a failure in the highway surface.

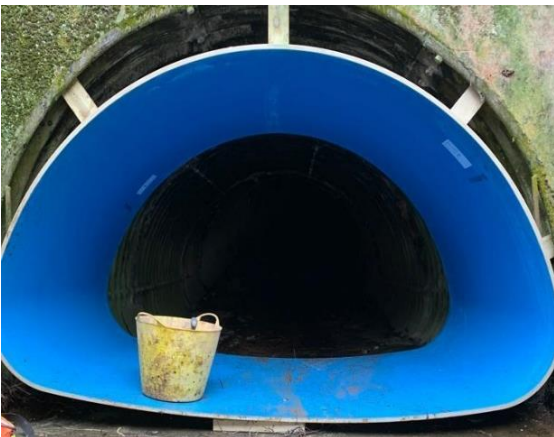
Fig 2: Site preparation. Courtesy of MDA Ltd

Work commenced on site on 14 February with site preparation works. Installation into the culvert commenced in March. In total, all installation and annulus grouting operations were completed in just 8 weeks.

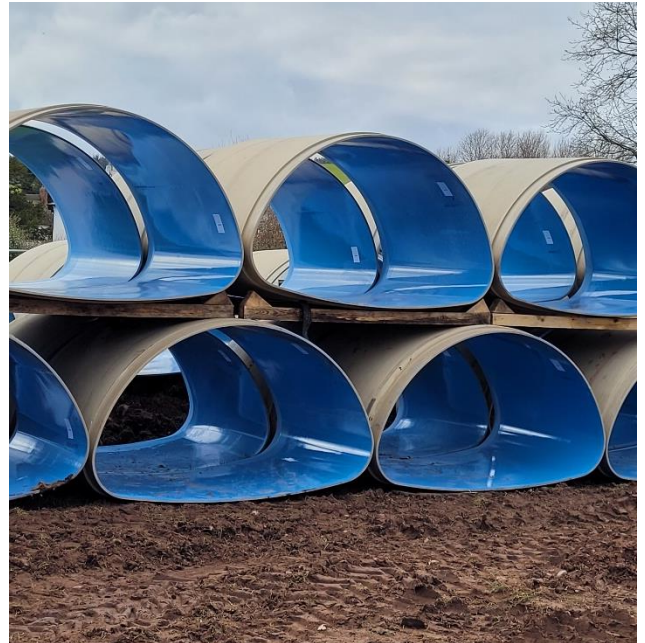
Fig 3: Amiblu NC Line 2360 x1350mm ready for installation

appointed specialist contractor Matt Durbin Associates to consult on rehabilitation options and carry out the work. Given that the location was a highly trafficked residential area with minimum cover to the road, it was decided that lining with a structural GRP segment lining system offered the best solution and Amiblu's NC Line, non-circular GRP Structural Relining system was selected for the project. In total some 300 metres of Amiblu NC Line Arch Shape liner, 2360mm wide x 1350mm high was manufactured to the required WRC Type II standard and ISO 16611.

The culvert meandered with the local water course, and on inspection for the design of the linings was found to include long radius bends which were designed for premanufacture so that they would install without issue on site.

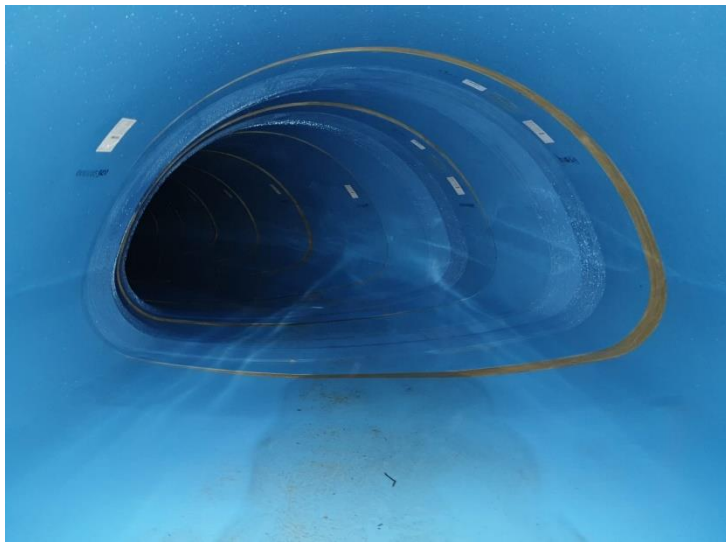
Fig 4: Completed installation. Courtesy of MDA Ltd

Despite the apparent loss of cross-section in the culvert the design and smooth internal finish of the linings ensured that the flow capacity requirements for the culvert would be met.

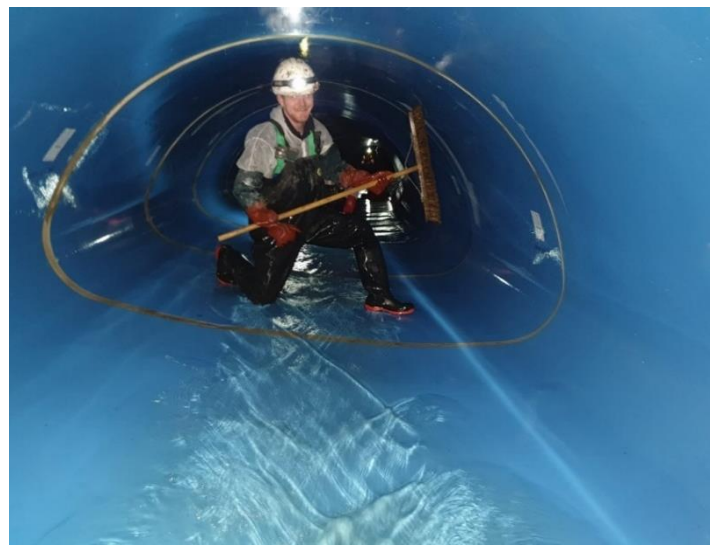
Fig 5: Completed installation. Courtesy of MDA Ltd
