## Shaft-in-Shaft Rehabilitation & Shaft Renovation

Effective Rehab Methods by HOBAS®

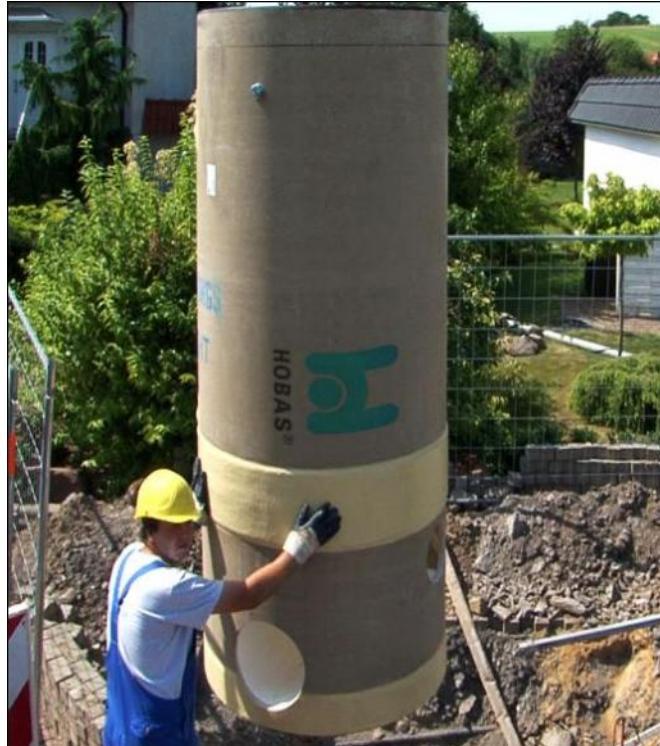
DE09SHL\_Schockwitz 1: New GRP Shaft lowered into existing shaft

A concrete shaft DN 1200 in Schockwitz near Halle for example was severely damaged and statically no longer stable due to corrosive sulphuric water. After an extensive comparison of alternatives, the Salza Sewage and Water Board (Abwasserzweckverband Salza) decided that HOBAS Shaft-in-Shaft Rehabilitation was the most suitable solution in both technological and economic terms. With this method, a new CC-GRP Shaft is placed into the existing structure to reestablish its static stability. The shaft is as good as new without having to take the old one down.

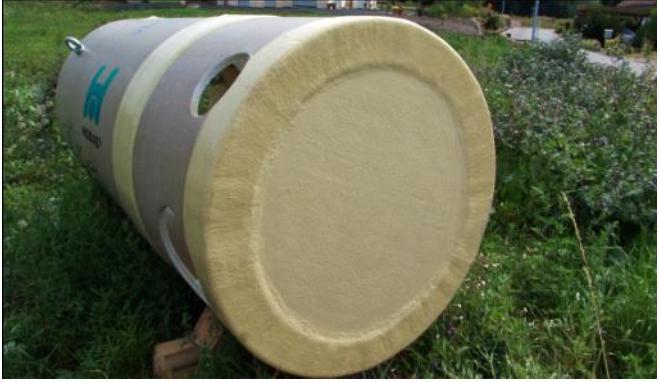
DE09SHL\_Schockwitz 2: One-piece CC-GRP Shaft for Shaft-in-Shaft Rehabilitation

The advantage of HOBAS ShaftLine Products is the minimal loss in cross-section, for they are not only relatively light walled, they moreover can be produced at variable lengths and with a wide range of diameters. Consequently, the cross section is reduced by only a few millimeters. The one-piece seamless CC-GRP Shafts are suitable for very deep structures as well. Due to their low weight, they can be installed with the help of light construction equipment only, which is an important point regarding cost saving.

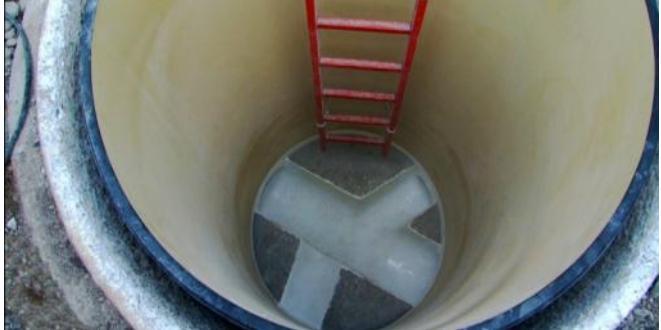
DE09SHL\_Schockwitz 3: Minimal loss in cross-section

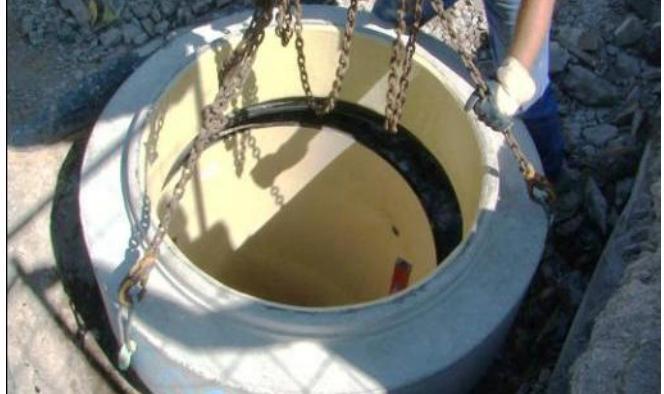
DE09SHL\_Schockwitz 4: Fitting a concrete cone onto the shaft

A further advantage of HOBAS Shaft-in-Shaft Systems is that the GRP Shaft Channels need no sub-form. This ensures a trouble free implementation of all required radii and bends for the connections. The gap between the new shaft and existing pipes is bridged using small pipe segments which are permanently fitted and sealed with GRP laminate without creating ridges in the channels. In the end, the laminate is once again completely sealed, the annulus is filled with liquid concrete mortar and the shaft's superstructure is restored. The concrete cone which in this project was supplied by a local builders' merchant, is sealed with laminate to ensure corrosion resistance. After fitting the concrete cone on top of the shaft, it is covered and the road repayed. The result: A permanently corrosion resistant and statically fully stable shaft.

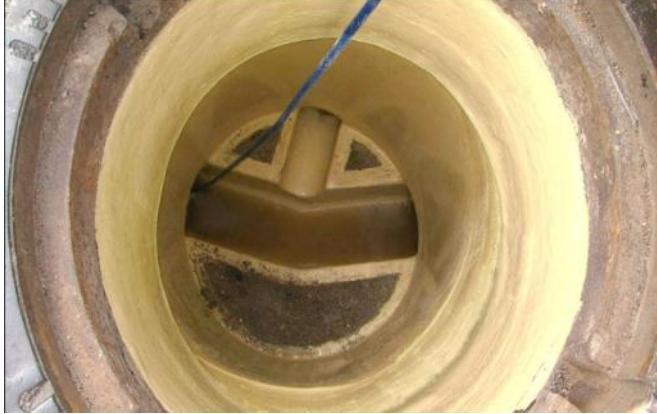
DE09SHL\_Salmuende 5: The GRP lining perfectly seals the old shaft

The prefabricated flexible GRP components provide a fast and non disruptive installation regarding traffic and are therefore optimal for urban areas. Moreover, the assembler can easily arrange the components in order for them to precisely correspond to all given shaft requirements on site. The shaft wall is then lined with a flexible HOBAS GRP Shaft Rehabilitation Pipe by effortlessly rolling it together until it fits through the 625 mm diameter of the standard shaft opening. All butts and edges are subsequently laminated with GRP and

thus completely sealed. Only a part in the upper area of the shaft remains clear to be able to fill the annulus with fluid concrete mortar. Once accomplished, also this part is sealed with GRP laminate.

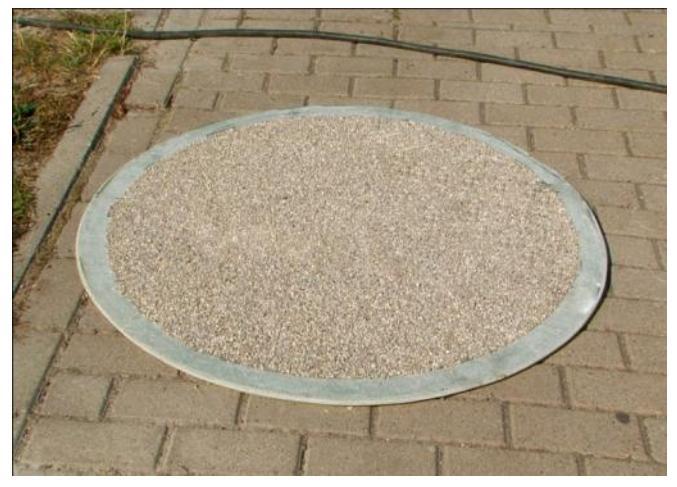
DE09SHL\_Schockwitz 6: No de- and repaving required
