## Bristol, UK – Damaged Sewer Relined & Restored

Damage caused by a driven sheet pile penetrating a sewer in the middle of a residential area of Bristol, UK, led to 32m of Amiblu's Hobas Jacking Pipe being installed to reline the ruptured section to restore the asset to full use.

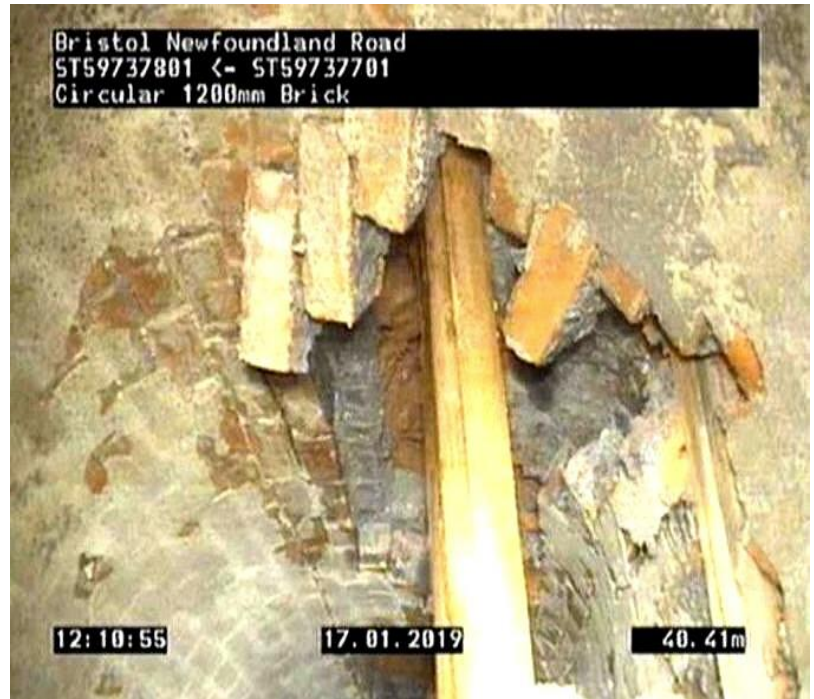
The original pipeline in Newfoundland Road was damaged by a sheet pile being driven through the existing double ring brick foul sewer, meaning the sewer flow was compromised for several months whilst a solution was designed.

Fig 1: Damaged pipeline

Given that Newfoundland Road is a busy residential area, replacing the damaged section of pipe by open cut methods would have proven very costly, environmentally unacceptable and disruptive to local inhabitants, so the solution to slip line the full length of the existing pipe from manhole to manhole was taken, ensuring minimal disturbance to the community and traffic.

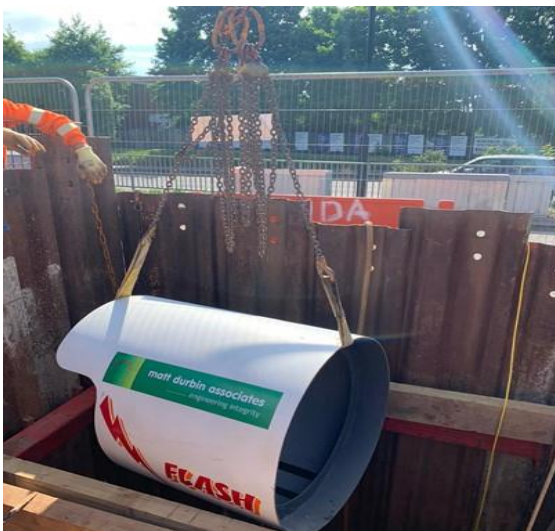
Fig 2: MDA Ltd works preparation

An access excavation was carried out onto the sewer where it avoided major utility services including a strategic gas main, to allow jacking operations. An insitu jacking wall was designed and installed to withstand any potential jacking forces that would be encountered.

Once the excavation works were complete, a specially fabricated shield was manufactured to suit the GRP jacking pipes which were then inserted past the point of the damage to the next manhole. Specialist mining techniques were used to excavate using the shield to maintain maximum safety at all times. Over-pumping was required to deal with foul flows during the works. Once the collapse had been removed the Hobas GRP jacking pipes were grouted into place using Pozament SPP3 to fill the annulus and transfer the brick sewer loadings to the new GRP liner.

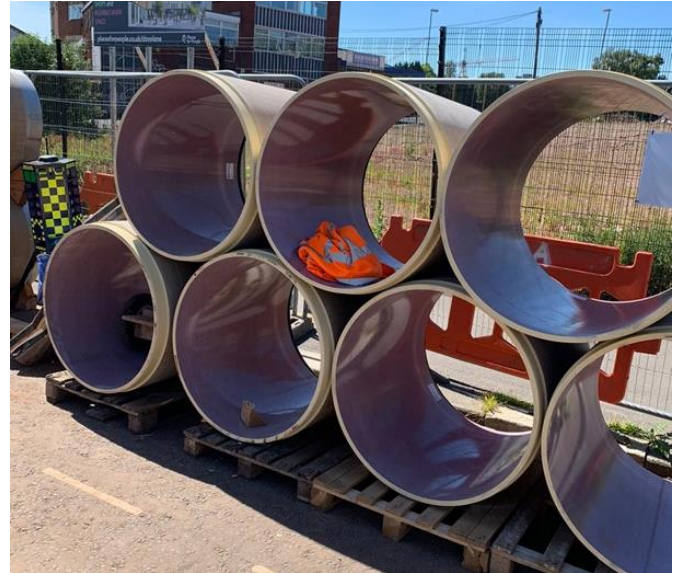
Fig 3: Amiblu DN900 Jacking Pipes

The structural integrity of the existing pipeline had been compromised, so following an engineering design, Hobas GRP SN32,000 jacking pipes were chosen as the optimal solution; the pipes were delivered in 1m lengths weighing just 199kg per metre with a wall thickness of 31mm ensuring minimal loss of capacity.

The equivalent pipe in concrete would have been too large for the jacking pit and would have weighed close to 1tonne per metre with a wall thickness of more than 90mm. Amiblu's jacking pipes are made in various lengths to suit project requirements from 1m to 6m and are engineered to give 150 years service life.

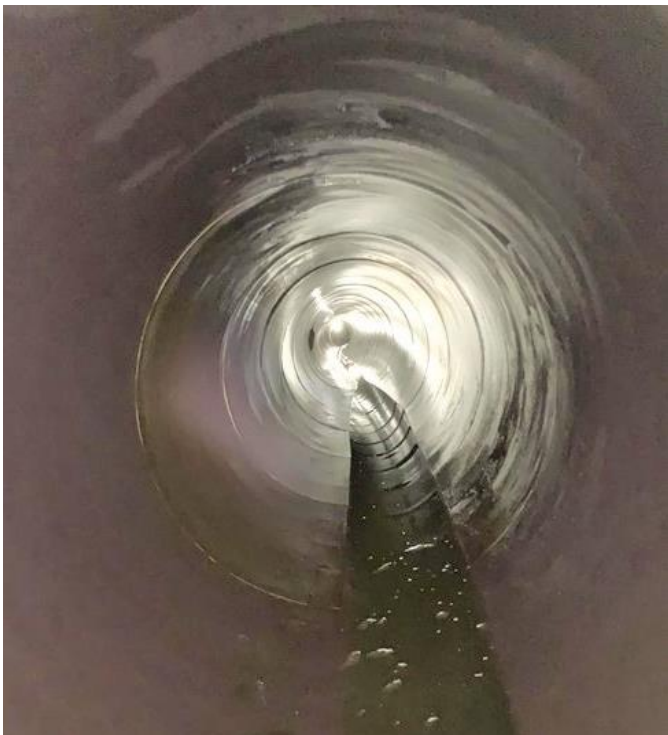
Fig 4: Restored pipeline ready for handover to Wessex Water
