# HOBAS® Case Study

September 2007

## Relining an Interceptor Sewer with HOBAS® CC-GRP Pipe Systems

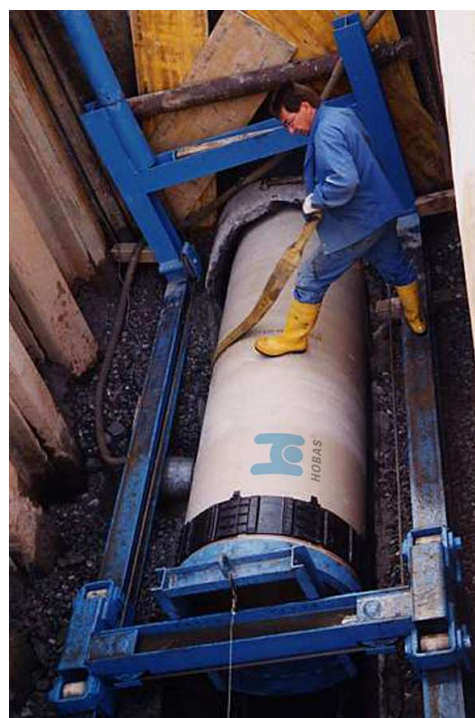
Before starting with the rehabilitation, the sections were taken out of operation and the wastewater was rerouted. The launch shaft for installing the new pipe system was approximately eight times two meters and reached down to the bottom of the old pipe. Standard HOBAS Pipes with a length of six meters could be easily inserted. The shafts

were located at bends or manholes of the old pipeline.

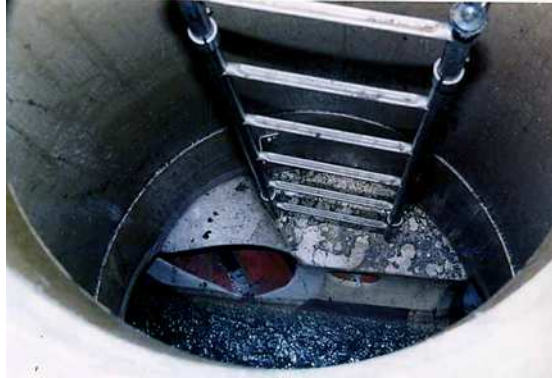
Then the old pipe in each entry shaft was cut open lengthwise and used as an insertion guide for the new liner pipes. Pipes were simply driven through manholes that were no longer required; manholes at pipeline bends were replaced with smaller HOBAS Bends or rehabilitated using HOBAS GRP.

Prior to relining, PE skids were mounted on the pipe spigots to prevent damage to the external pipe wall during insertion, to ensure a safe position and to minimize the floating effect when grouting. Then a liner pipe was inserted in the existing shell and pushed in with a hydraulic jack. The next length was joined in the entry shaft, jacked and so on, section by section.
