Turning Old into New

Rehabilitation with HOBAS® Pipes in Germany

Rehabilitation instead of replacement in Cologne

Relining premiere with GRP pipes in Würzburg

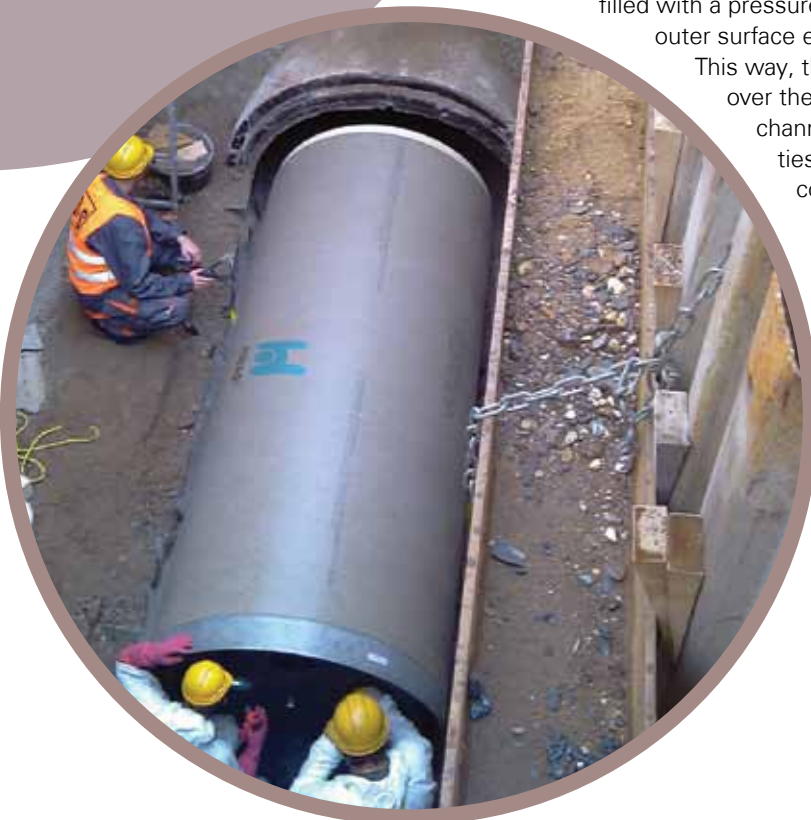
The specific mirror-like inner surface of HOBAS GRP Pipes made a reduction in the cross section possible. Three meter long circular HOBAS Pipes D_e 1280 were supplied, and starting and receiving pits of 5 x 4 m each excavated for their installation. By means of a winch, the pipes were drawn inside the old structure and jointed. The remaining annular space between the old and new pipeline was filled with a pressure-resistant material, and a sand coating of the pipes' outer surface ensured a particularly good bonding of the grouting.

This way, the inserted pipe was fixed in its position and took over the entire load-bearing capacity. Given its walkability, the channel needed to come with ideal anti-slip safety properties, which is why the bottom of the pipe has also been coated with sand.

In the course of a routine check of the sewer system, the sewage board in Cologne found a combined sewer DN 1500 in the urban district Sürth to be severely damaged: The concrete pipes showed numerous longitudinal cracks, which affected the 80 m long channel's structural capability. Above all, a leakage of the combined sewage could not be ruled out, and this was a serious problem since the district is located in a water protection area close to the river Rhine. The decision to rehabilitate the affected section with HOBAS Relining Pipes was linked to technical and economic interests.

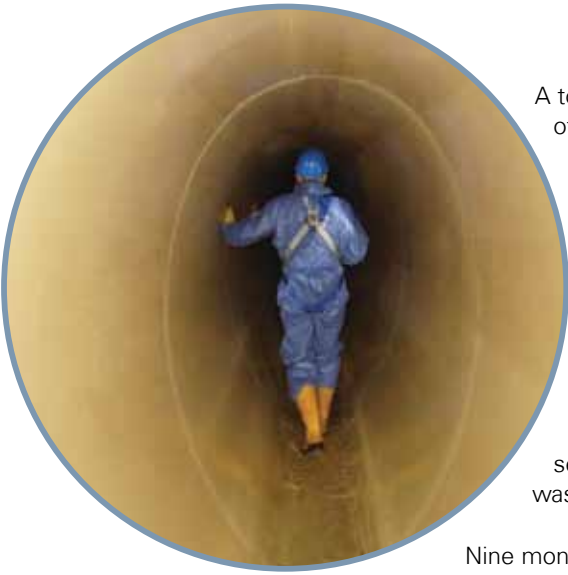
A total of 401 NC Line Profiles in lengths of 1 to 2.35 m and with a wall thickness of 25 mm were used in the rehabilitation of the old sewer. Due to the heavy traffic and the limited storage space on site, the GRP pipes' delivery, storage, and installation had to be absolutely reliable and trouble-free. With the help of a so-called "pipe shuttle"; a carriage designed specifically for this project by the construction company Aarsleff, the pipes were lifted and transported to the construction pit. The installation works were conducted from one single pit, which is why 533 m pipes were installed in flow direction and another 342 m to the opposite direction. In the areas of manholes and special structures, the GRP profiles were cut open according to the man-hole dimensions in order to create accesses and emergency exits. Then, the pipes were connected with push-to-fit couplings using a coupling device and secured against buoyancy by means of spacers. The 3 cm wide annular space was eventually grouted.

The egg-shaped brick sewer had no standard dimensions, but a special cross-section of 1400 x 2250 mm. For the rehabilitation of the 875 m long section, HOBAS NC Line Profiles 1260 x 2110 mm were used. Prior to the start of the actual rehabilitation works, the old sewer’s profile had to be digitized with a 3D laser scanner. The resulting three-dimensional image of the channel served as the basis for the installation plan. In another preparatory step, a water retention system had to be built. A diversion of the wastewater would not have been economically viable, which is why the works had to be interrupted in the event of rain so the channel could be abandoned within 30 min only – in the worst case, the channel would in fact be flooded. This flexibility is in fact one of the big advantages of relining. In order to guarantee a continuous on-the-job safety, a warning system with several level meters was installed. At the same time, a winding mandrel was produced and the HOBAS Pipes’ resin-rich inner liner applied to it. Afterwards, the non-circular pipe wall was built up by means of filament winding.
