Storm Drain Line in Michigan Successfully Relined with HOBAS® Pipes, US

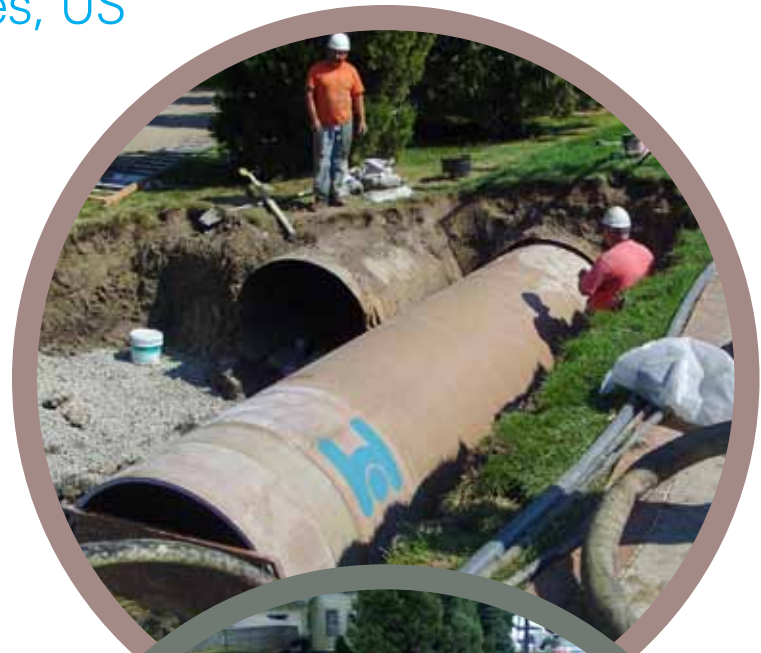
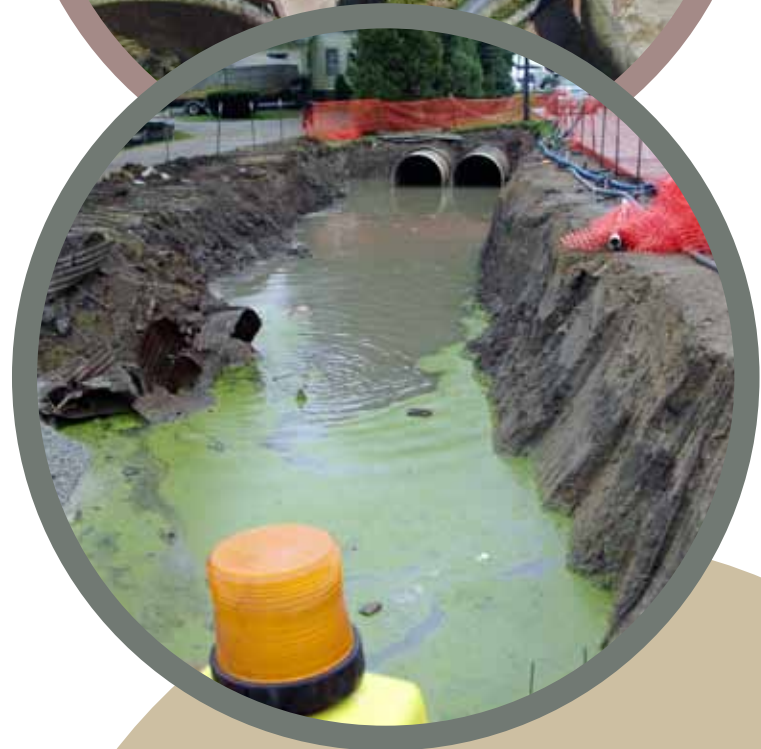
Tyger started work on the line in September 2009. The 6-m-long sections of DN 1350, SN 8900 pipe were inserted into an existing

DN 1500 corrugated metal pipe (CMP). To ease installation into the deteriorated line the new pipes were manufactured with a flush bell spigot. The liner pipe was installed in two runs of 75 m each and utilized open cut installation methods for the 3 m area where the 6 by 3 m sinkhole originally appeared.

The material's strength proved its worth where the pipe had to be jacked into place – being pushed through the existing pipe that was filled with soil. Once the CC-GRP was in place, the material was excavated from within the pipe. After insertion, the annular space between the liner pipe and the deteriorated CMP was grouted. The grout used to fill the annular space gives off heat as it cures, and can cause problems for some pipes that are not as heat resistant. CC-GRP, however, is a thermosetting material and is thus not as affected by elevated temperatures as many thermoplastics which lose properties more rapidly. This means that HOBAS Pipes can maintain adequate strength and, therefore, resistance to collapse during grouting.
