Liver than Live Rehab

Sliplining HOBAS® Pipes Under Airport Runway, US

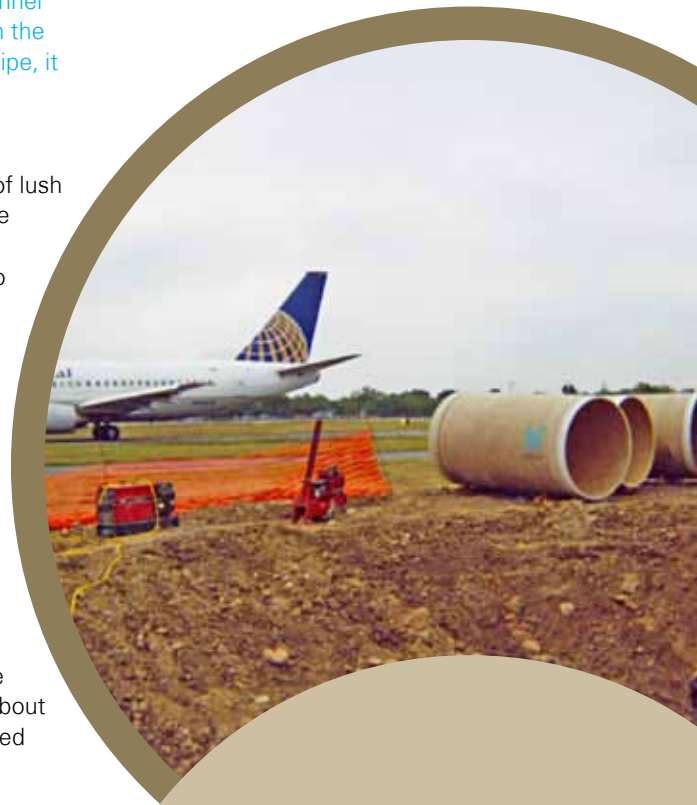
Year of construction
2004
Total length of pipe
332 m
Pressure class
PN 1
Diameter
DN 1600
Stiffness class
SN 10000
Installation method
Relining

Application
Raw water supply line
Client
City of McAllen
Contractor
Summit Contracting
Advantages
Leak-free pipeline, existing pipeline and runway remained in service during the installation process

Summit evaluated the line and devised a plan to install the new pipe. Consulting engineer HNTB specified a 1600 mm diameter CC-GRP pipe, since it met both the hydraulic considerations and the clearance required by the installer. The largest angular bend in the line was at about the midpoint under the active runway 13/31 and could not be navigated with pipe sections. Closing the runway was, however, not an option.

"We fabricated a buggy that we utilized to carry the pipes into the existing line," stated Ben Salinas, vice president of Summit Contracting. "The first segment placed at the line midpoint was a mitered fitting with an angle that corresponded exactly to the angle measured." Subsequent pipes and mitered fittings were carried in from either end of the line until the entire 332 meters of line was rehabilitated. The so-called live sliplining took on a new meaning because air traffic on the surface continued with no major inconveniences while the old pipeline remained in service.
